REPAIR, EVALUATION, MAINTENANCE, AND  
REHABILITATION RESEARCH PROGRAM

TECHNICAL REPORT REMR-CO-2

PROTOTYPE EXPERIENCE WITH THE USE  
OF DISSIMILAR ARMOR FOR REPAIR AND  
REHABILITATION OF RUBBLE-MOUND  
COASTAL STRUCTURES

Robert D. Carver

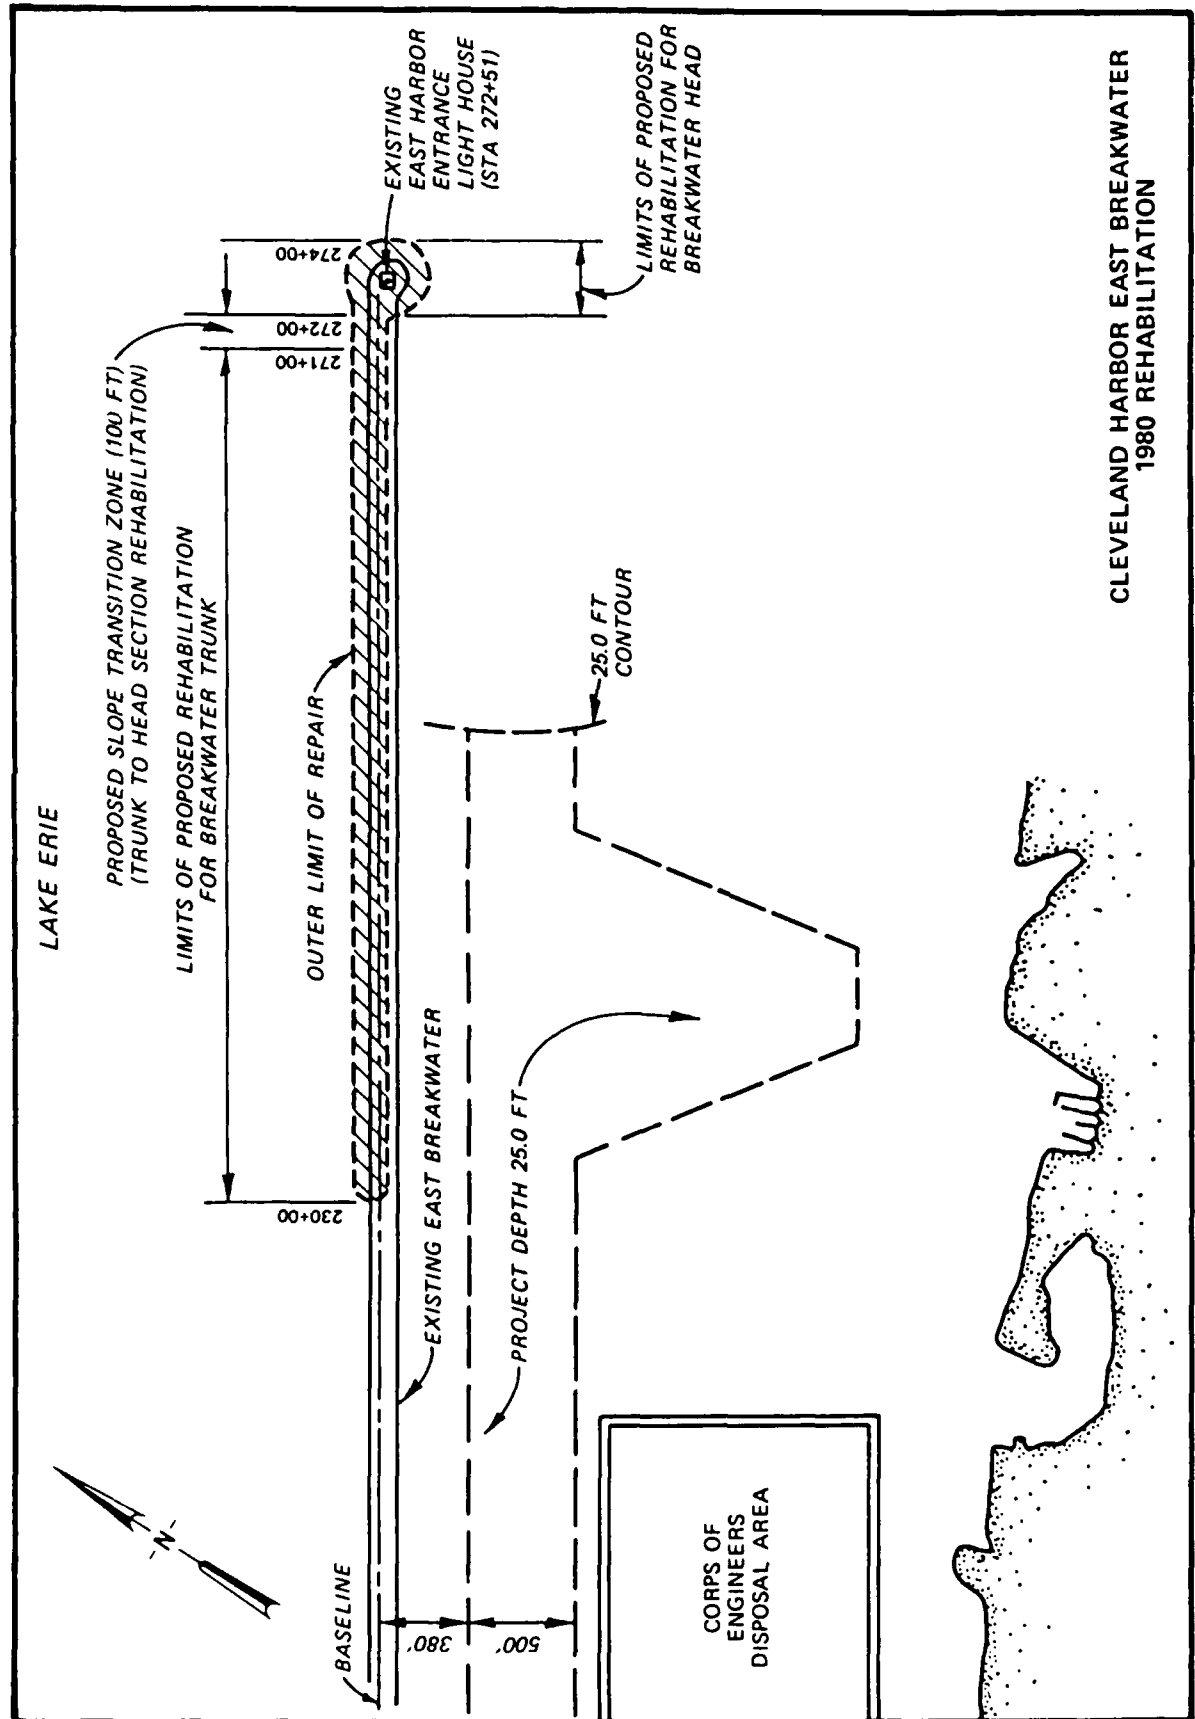
PLATE 2

construction similar to that in the original work, workmen made repairs on the east breakwater in the years 1927, 1928, 1930, 1932 to 1940, and 1946 to 1978. During 1980, the eastern 4,400 ft of the east breakwater was rehabilitated (Plate 2). Two layers of 2-ton unreinforced dolosse were placed on the lakeside of the trunk and around the east head (Plates 3 and 4, respectively); 29,700 dolosse were placed with a concentration of 161 dolosse per 25 lin ft of the breakwater. On 6 April 1982, a particularly severe storm (hindcast waves of 12 ft in height) occurred simultaneously with the highest lake level (+6.1 ft low water datum) ever recorded and caused damage to the rehabilitated dolos section. Although there was some displacement of dolosse over the crest of the trunk section, primary damage was localized on the tip of the head section where a hole about 20 ft in diameter at the armor surface penetrated to the original stone. The number of units broken due to displacement from the damage hole is not known, but total breakage on the entire dolos section after the April 1982 storm was reported as 487 or 1.6 percent of the units placed. A diver's survey indicated that the broken dolosse are generally in a zone 4 to 6 ft above and below the water level. The head section was repaired in September 1982 by placing approximately 200 dolosse in the localized damage area. Presently (1985), plans are being formulated for rehabilitation of an additional 3,300 ft of the east breakwater trunk using two layers of 9- to 20-ton armor stone (Plate 5). Table 2 summarizes the construction and rehabilitation history of the breakwater.
